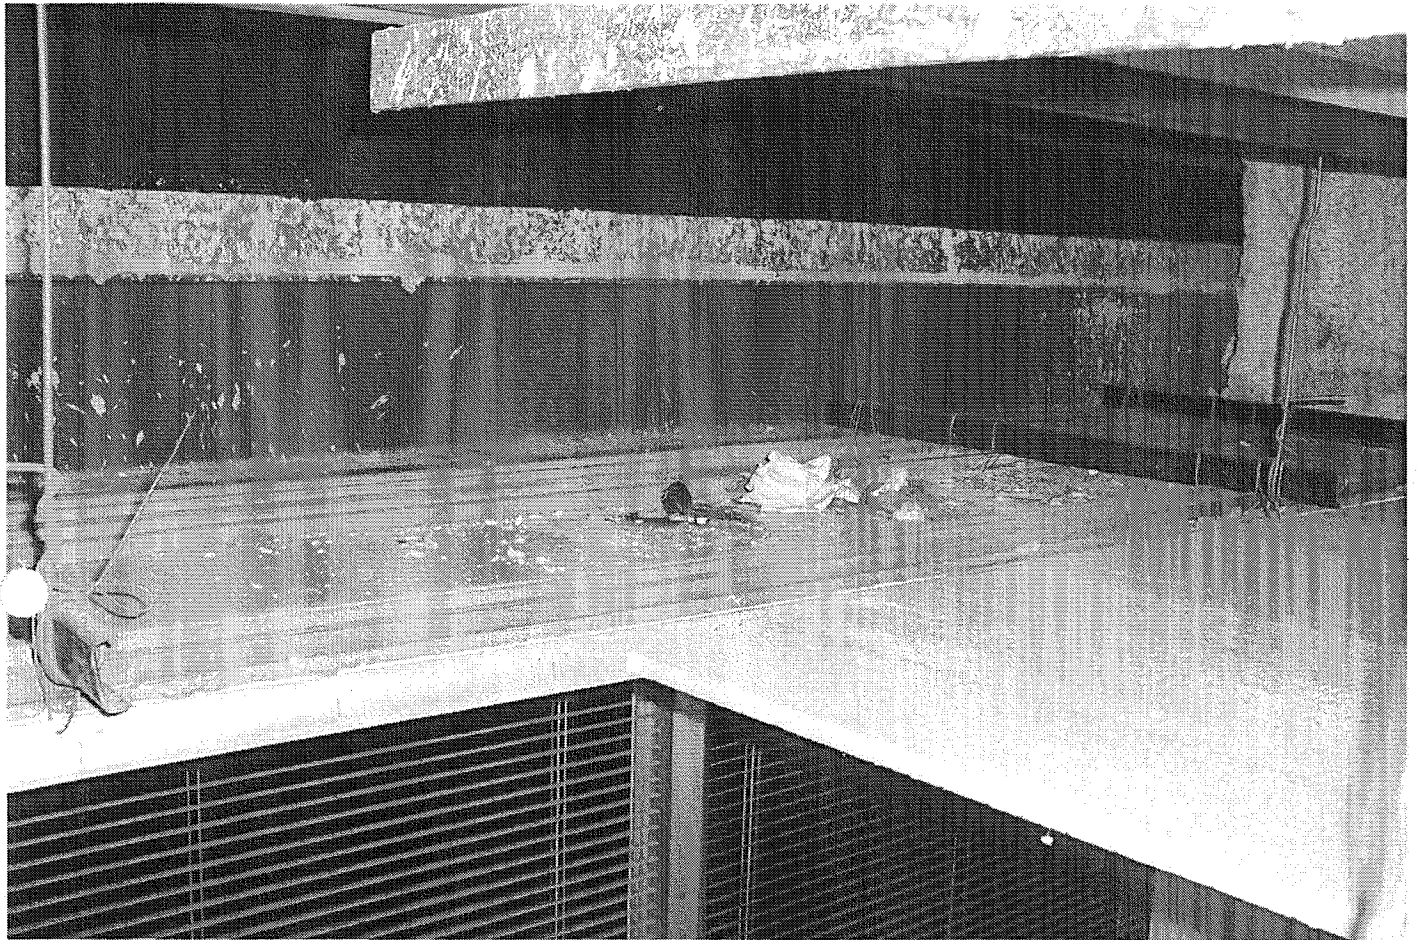
47. 2nd Floor Suite 261 - View of delaminated fireproofing on top of plaster perimeter ceiling

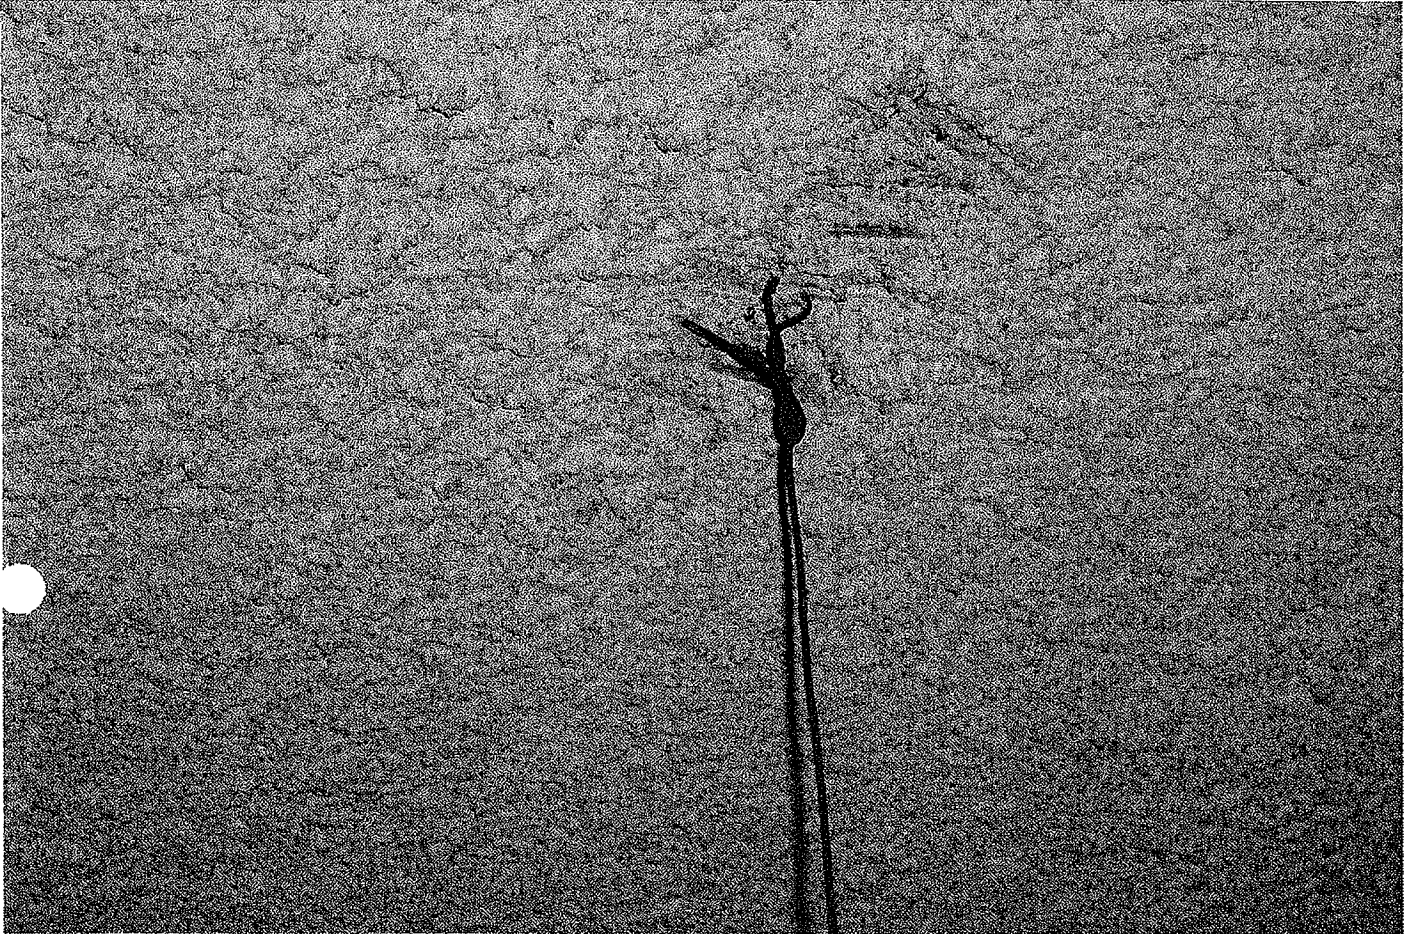
48. 2nd Floor Suite 261 - Disturbed fireproofing next to hanger wire on corrugated decking above suspended ceiling

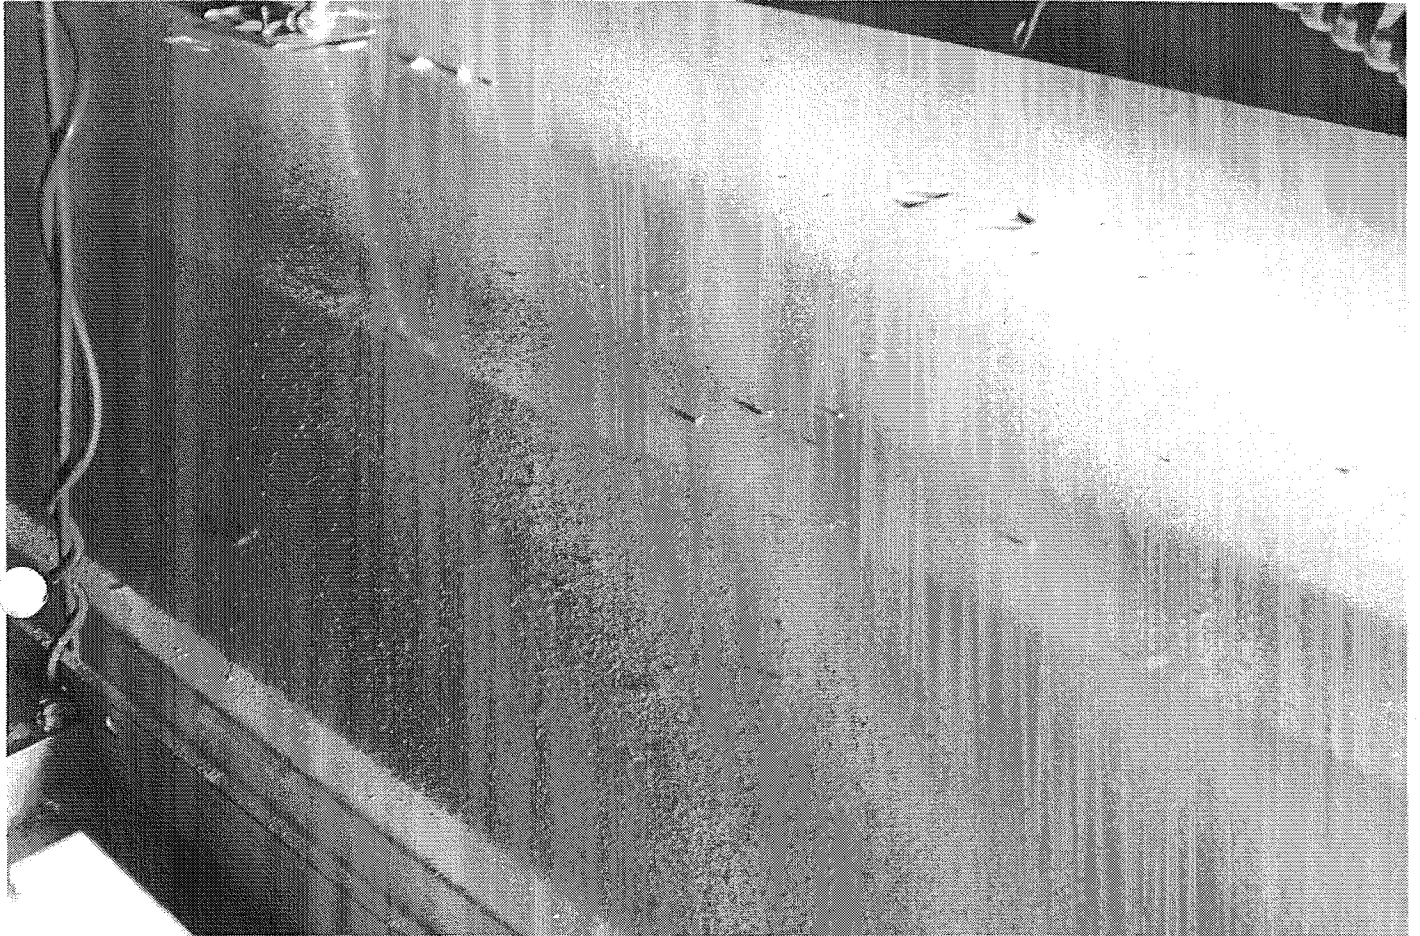
49. 2nd Floor Suite 261 - Close-up of fireproofing debris on top of fluorescent light fixture

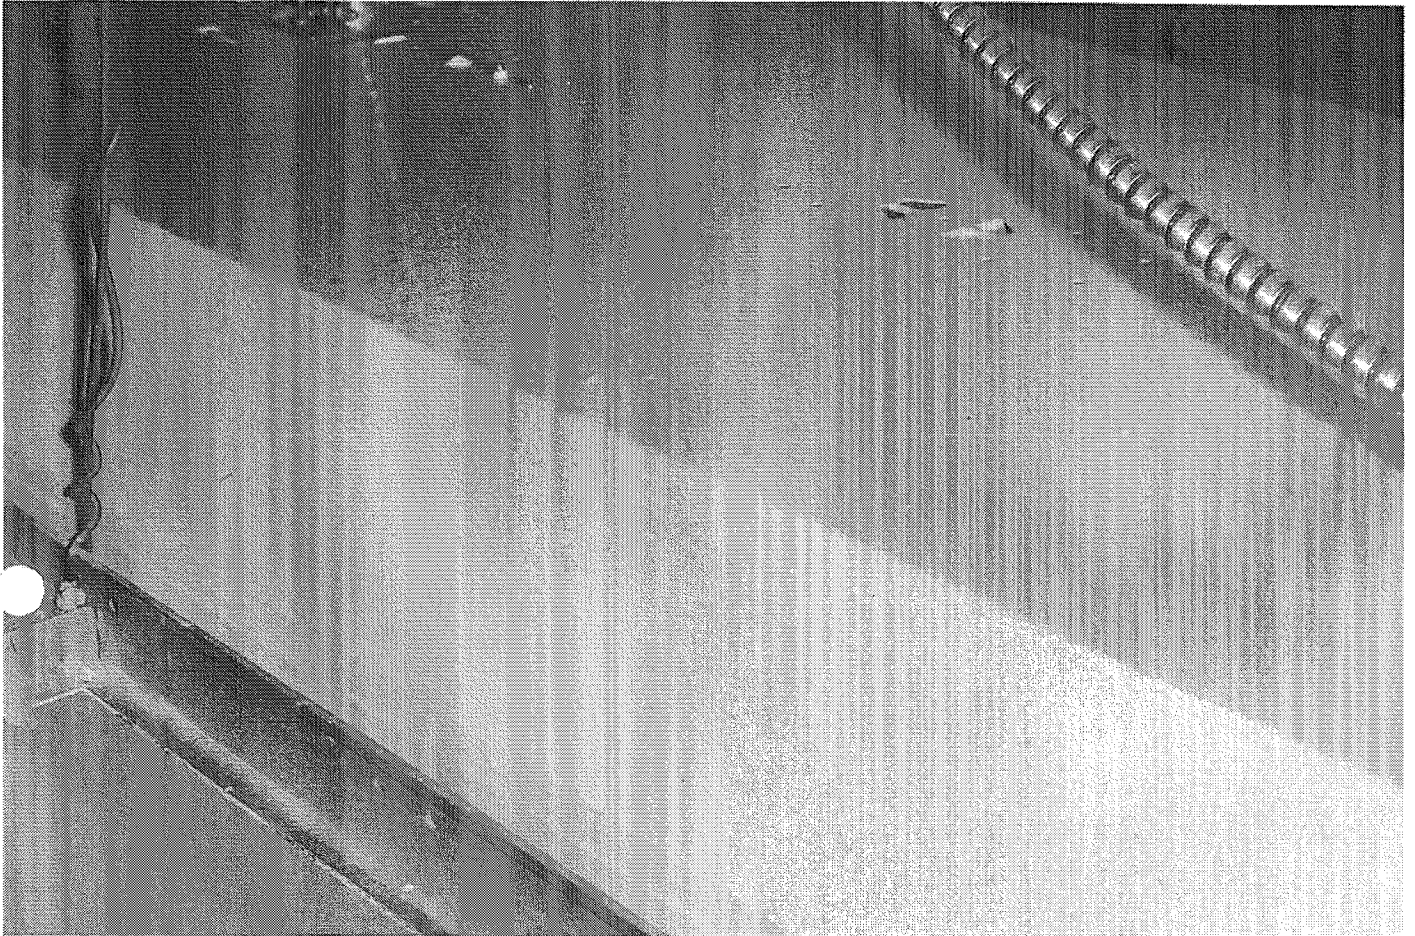
50. 2nd Floor Suite 261 - Close-up of fireproofing debris on top of fluorescent light fixture

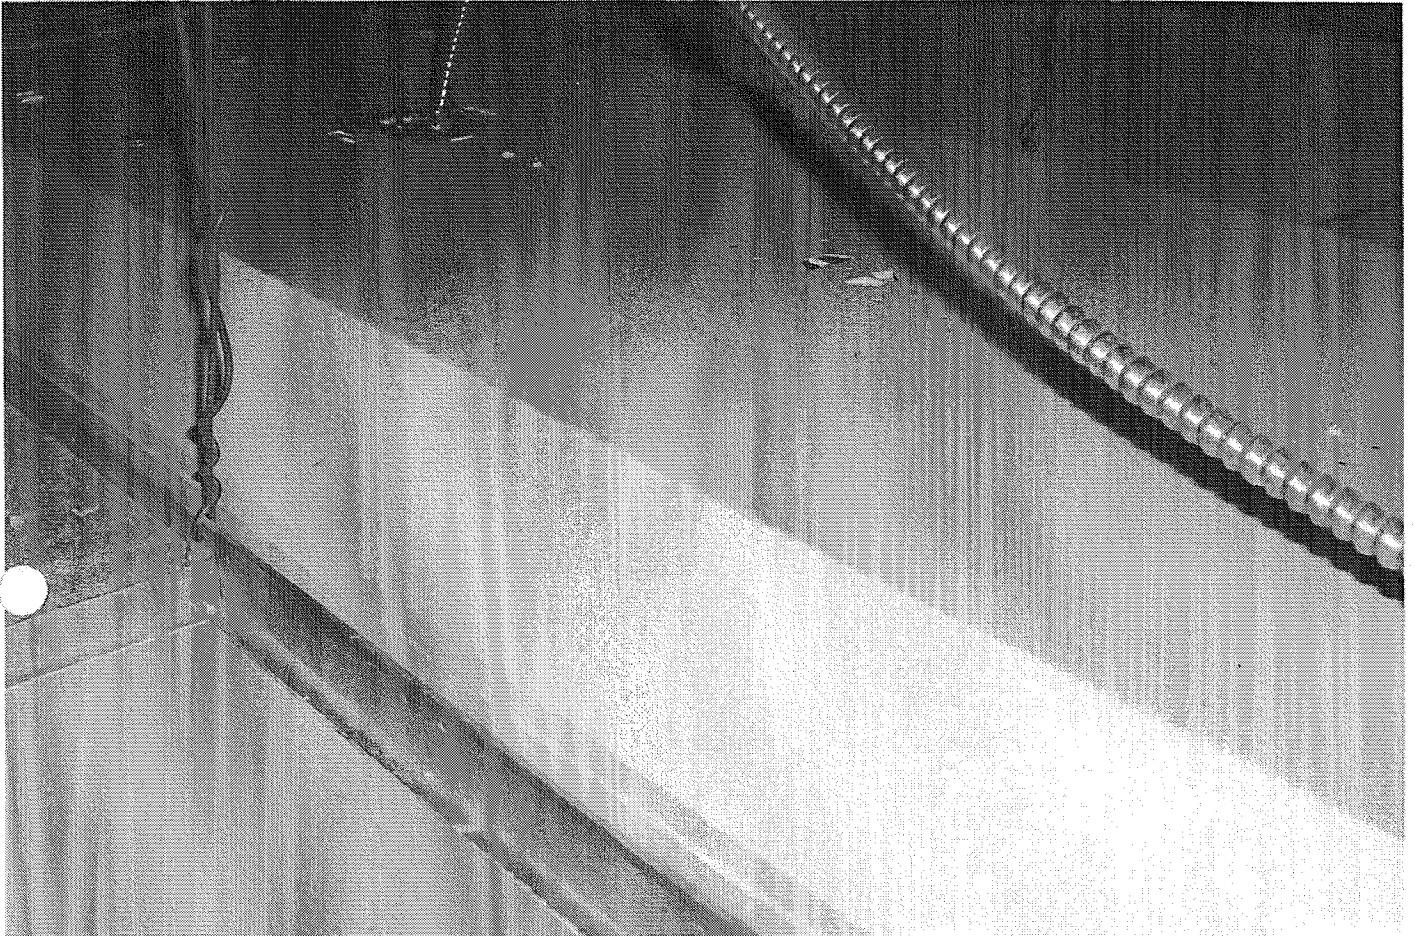
51. 4th Floor vacant center ste - Location of sample #3 - top of fluorescent light fixture

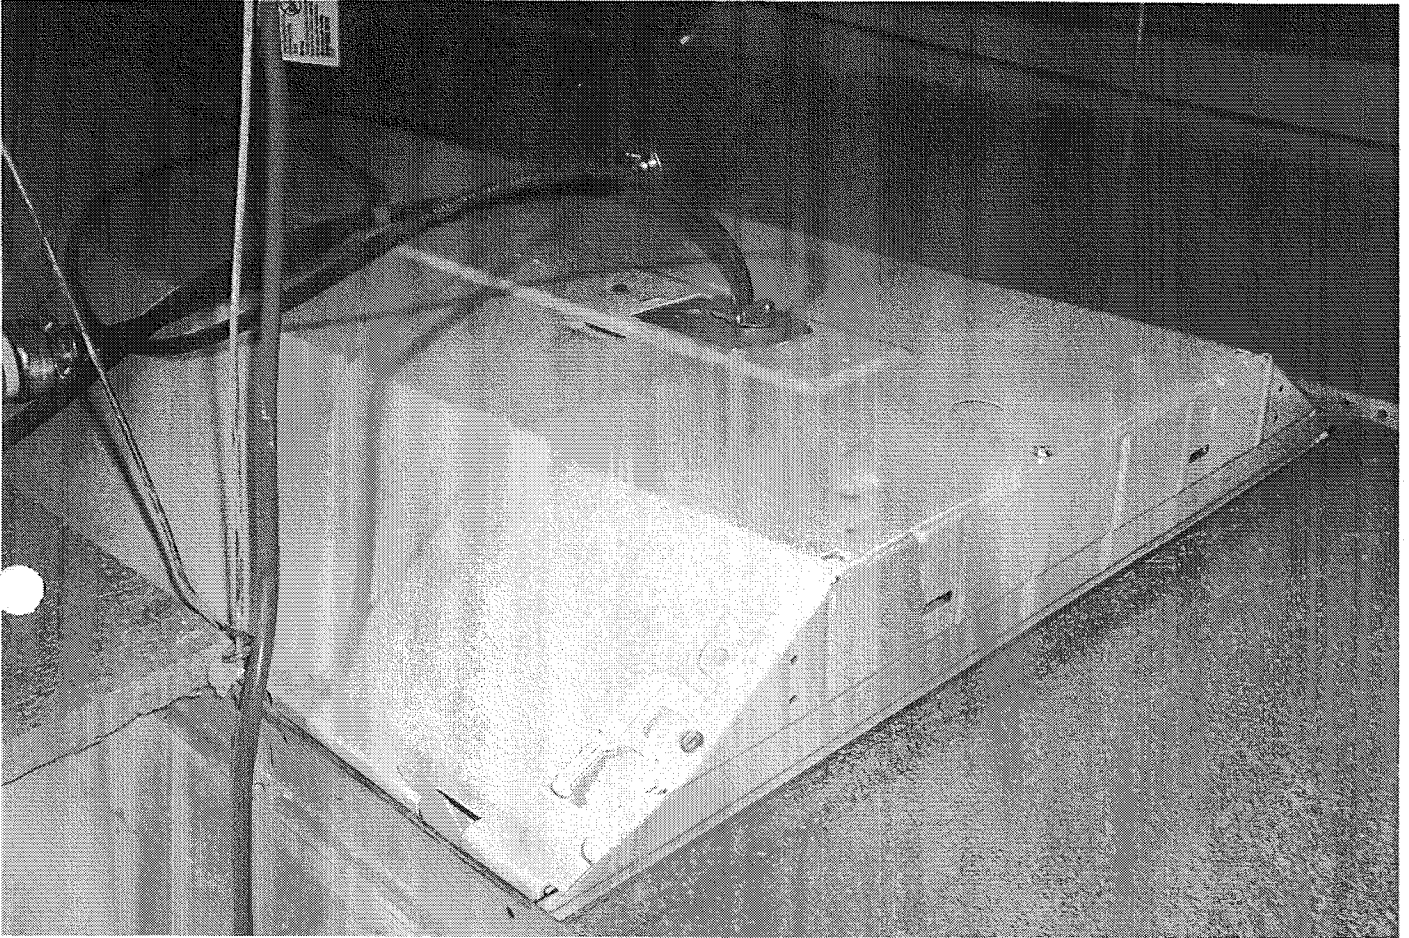
52. 4th Floor vacant center ste - Location of sample #4 - top of fluorescent light fixture
